Hood River - White Salmon

BRIDGE REPLACEMENT PROJECT

Final Hazardous Materials Technical Report

November 2020

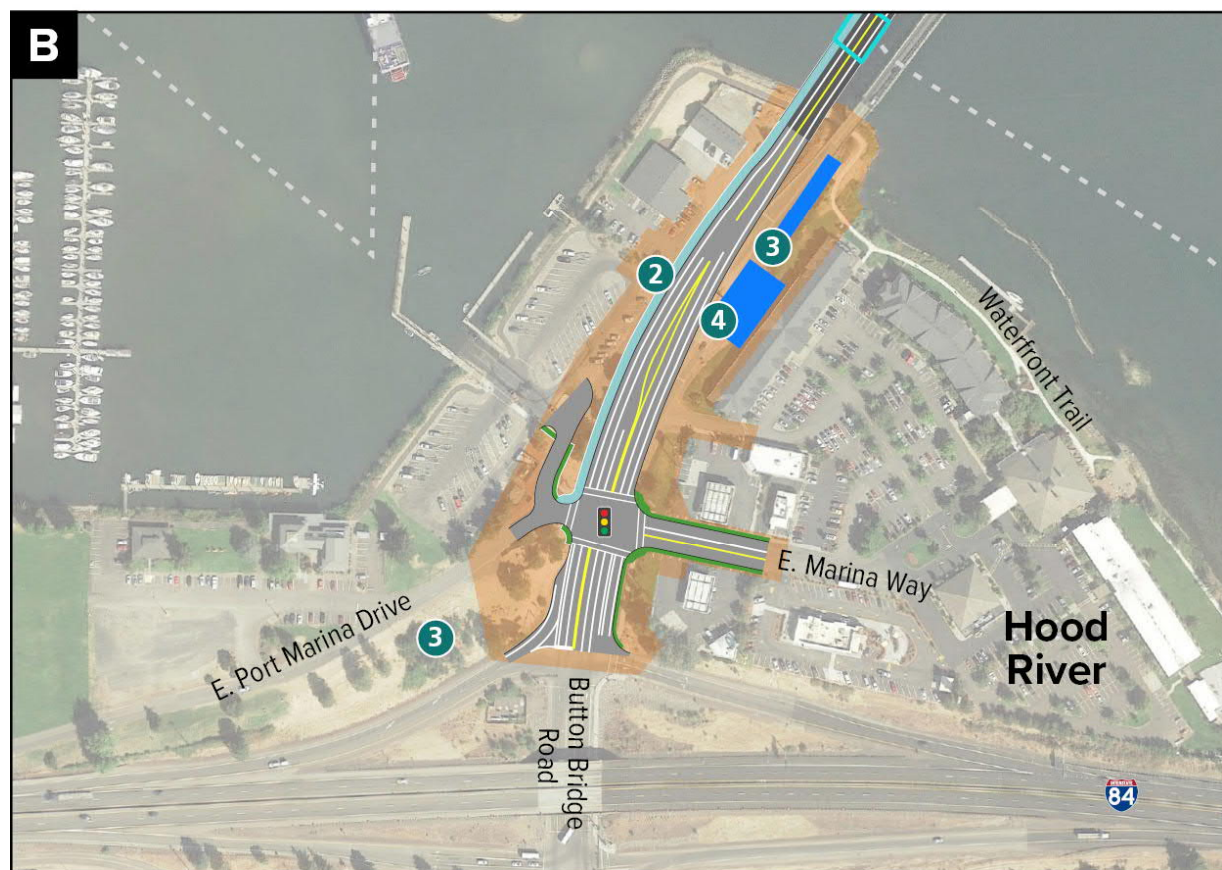
Exhibit 6. Preferred Alternative EC-2 Enlargements

- 1 New two-lane roundabout with marked crosswalks
- 2 New shared use path across bridge
- 3 New stormwater detention and water quality treatment facilities
- 4 Elimination of toll booth
- 5 New wider bridge opening crosses navigation channel at a perpendicular angle

- Roadway connections: The bridge would connect to SR 14 on the Washington side at a new two-lane roundabout slightly west of the existing SR 14/Hood River Bridge intersection, as shown in Exhibit 6. On the Oregon side, the southern end of the bridge would transition to Button Bridge Road, connecting to the local road network at the existing signalized Button Bridge Road/E. Marina Way intersection north of I-84. The private driveway on Button Bridge Road north of E. Marina Way may be closed under this alternative. Like the existing bridge, the replacement bridge would cross over the BNSF Railway tracks on the Washington side and over the Waterfront Trail along the Oregon shoreline.

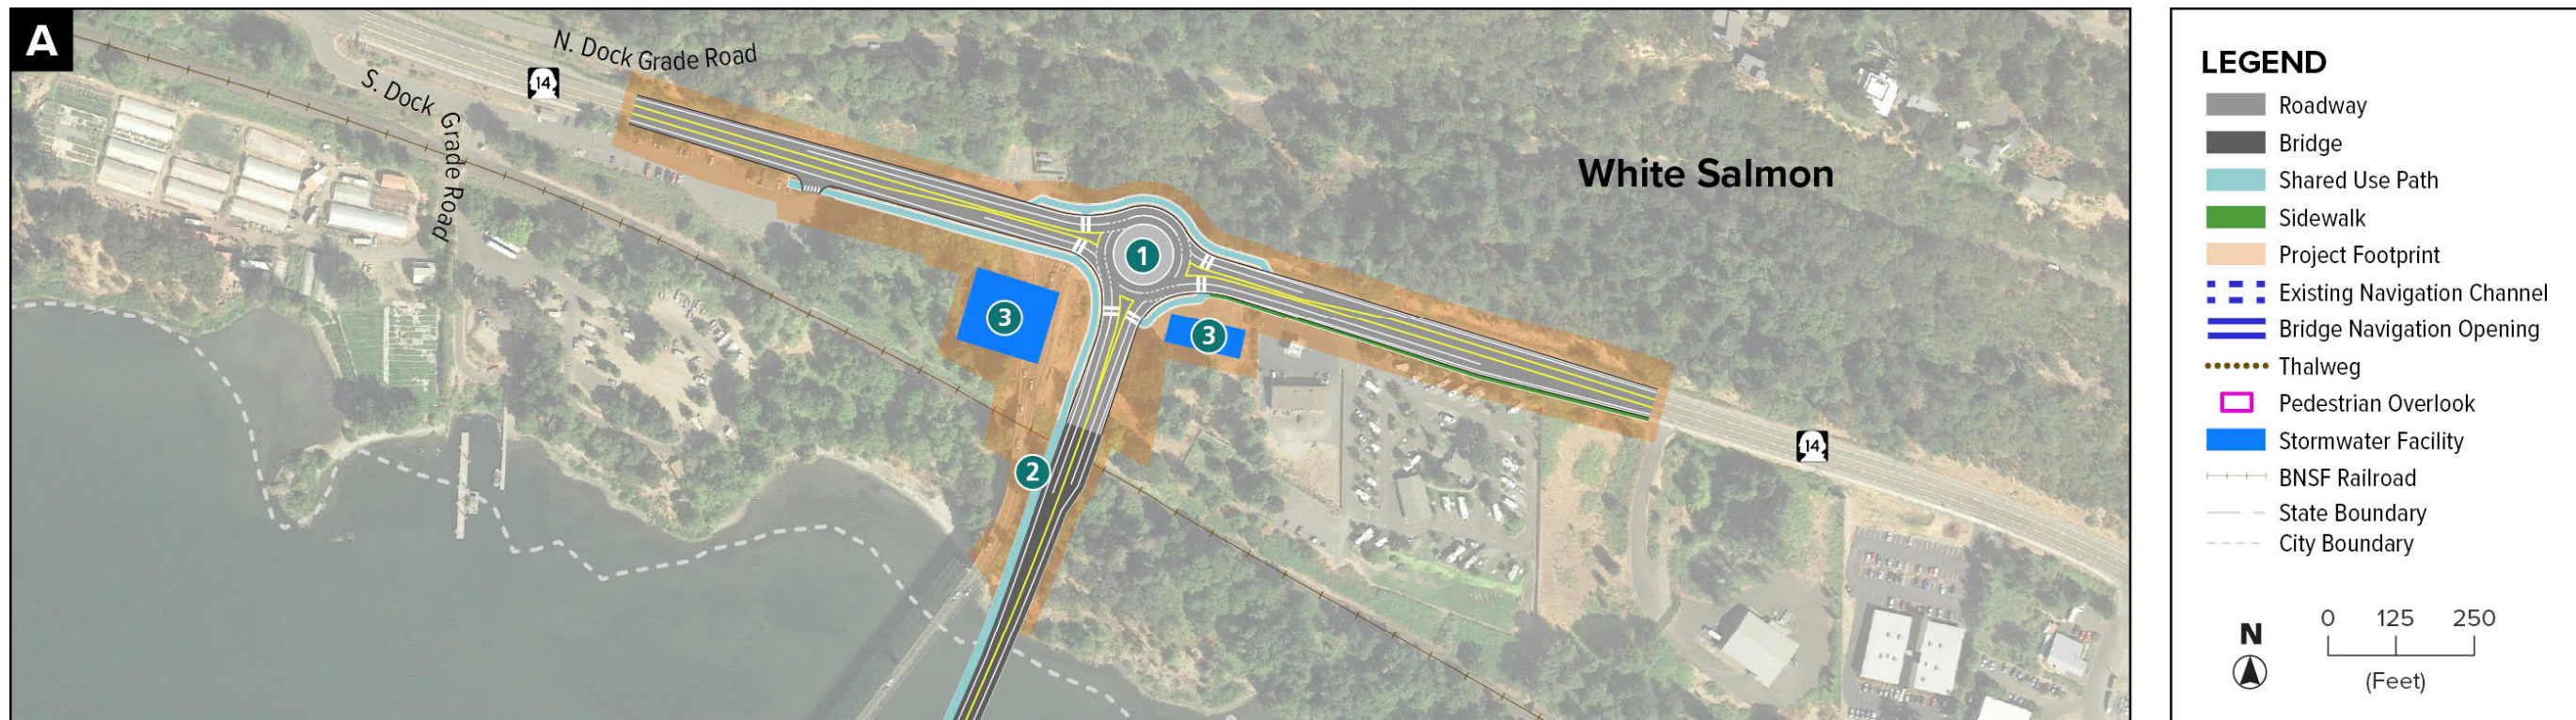
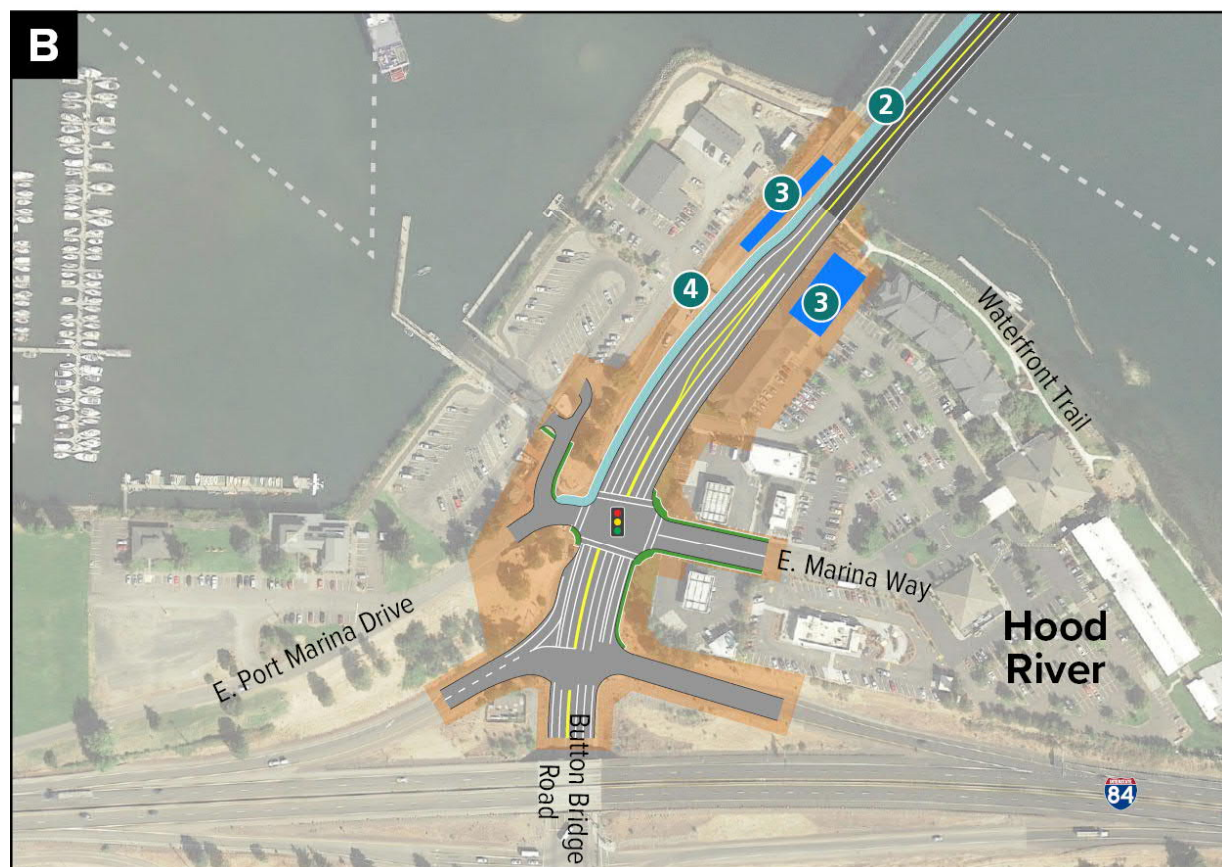
Exhibit 11. Alternative EC-3 Enlargements

- 1 New two-lane roundabout with marked crosswalks
- 2 New shared use path across bridge
- 3 New stormwater detention and water quality treatment facilities
- 4 Elimination of toll booth
- 5 New wider bridge opening crosses navigation channel at a perpendicular angle

- **Bicycle and pedestrian connections:** Connections to bicycle and pedestrian facilities would generally be the same as Alternative EC-2, but the roundabout intersection with SR 14 on the Washington side would be located approximately 264 feet further east than under Alternative EC-2.

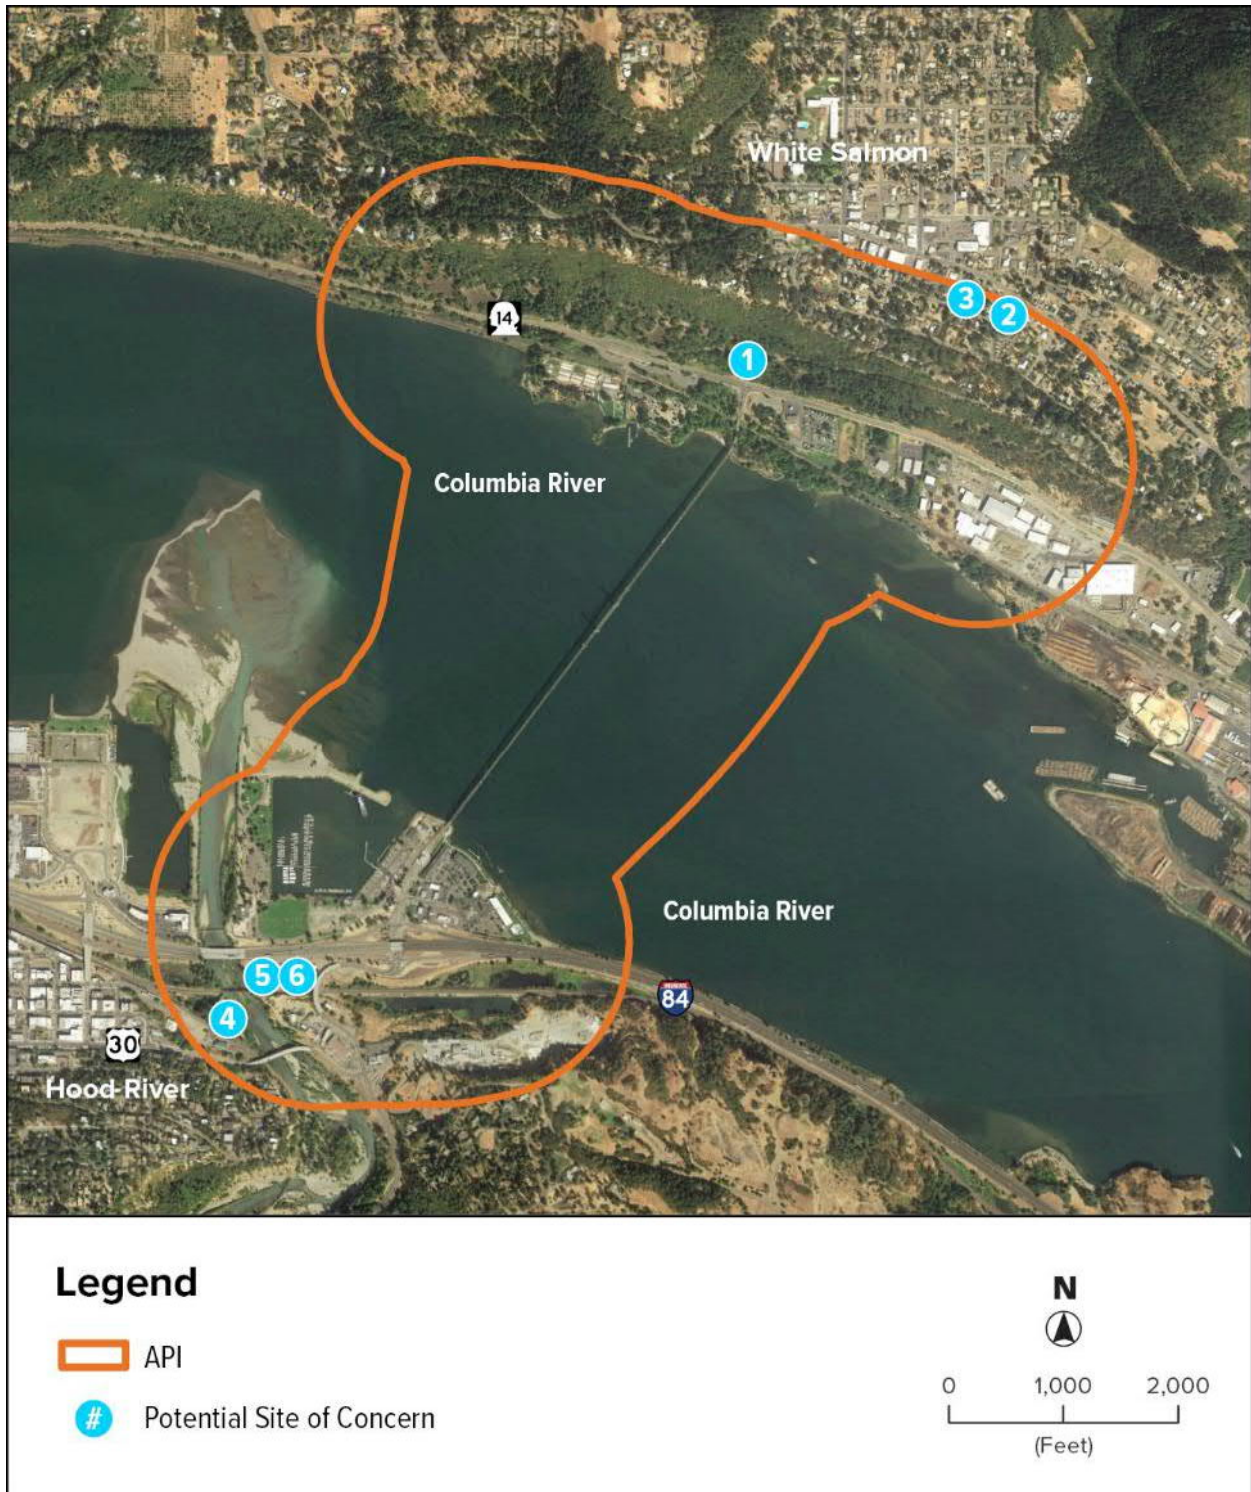
Exhibit 15. Sites of Environmental Concern to the Project

Twenty-six (26) sites of environmental concern were identified in the EDR Report and had adequate and complete address information to specifically locate on EDR Report maps. Nineteen (19) sites were reported with inadequate or incomplete address information, were not specifically located on maps, and were mostly related to spill sites for vehicles or vessels.
